沸水式反應器壓力邊界異材銲道 腐蝕疲勞行為研究

2009中華核能學會年會暨用過核燃料管理策略研討會

核能研究所

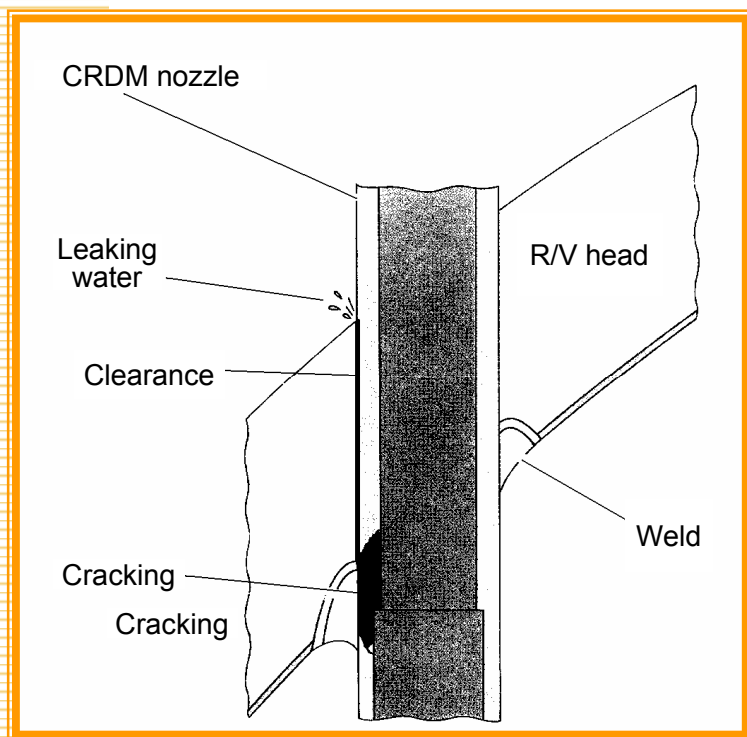
Example of Cracking in R/V Head Penetration Nozzle

Bugey-3 (France) ('91)

Axial cracking in base metal

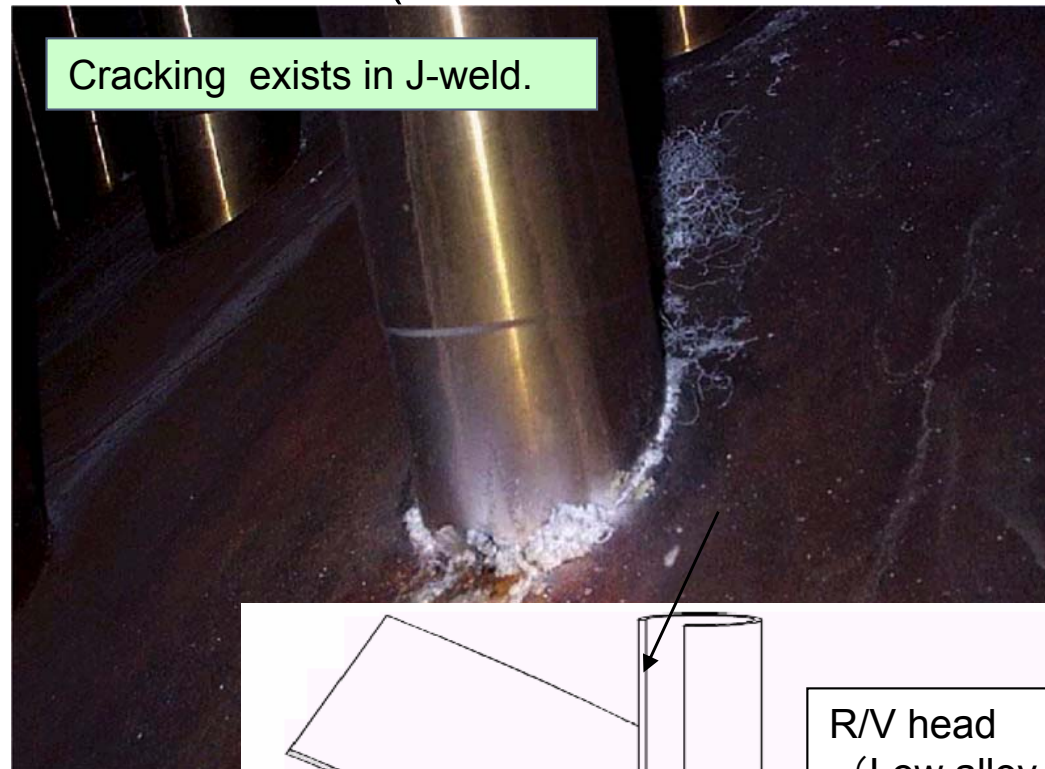
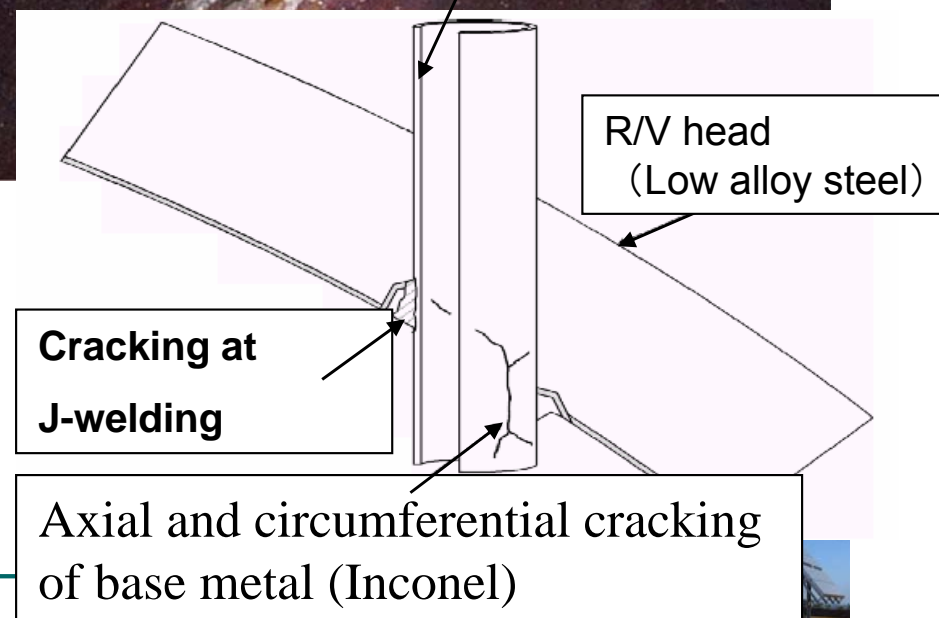
Oconee-3 (U.S.) ('01) start of operation: December 1974

Cracking exists in J-weld.

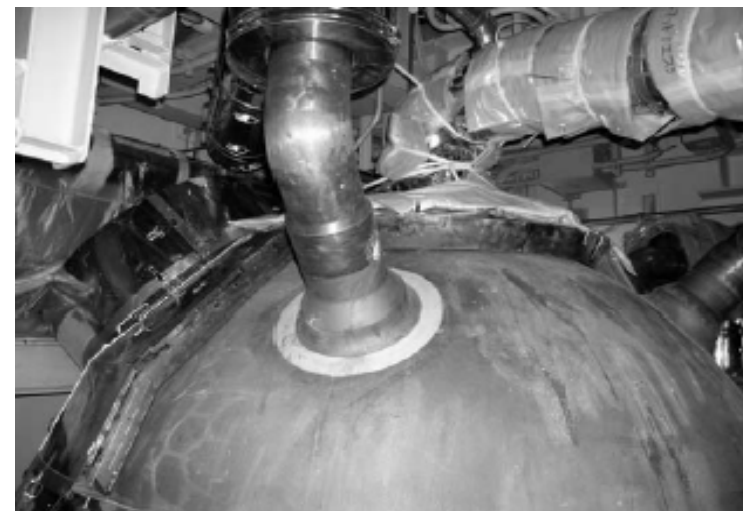
Tsuruga 2 Pressurizer Relief Nozzle Safe-end Leakage

Top of Pressurizer

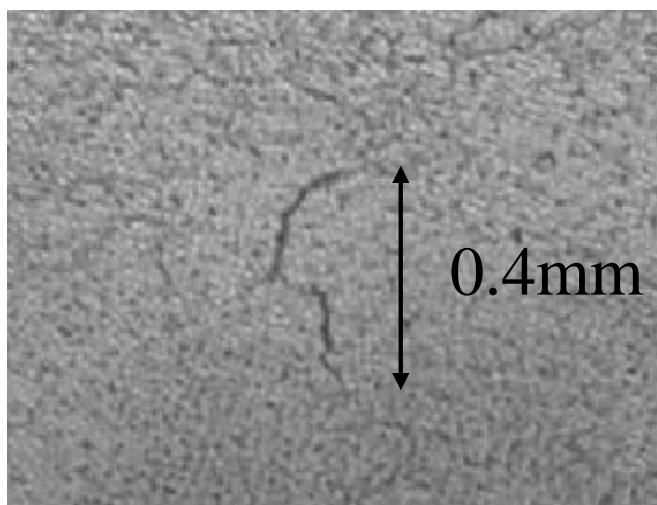
Micro Printing Result

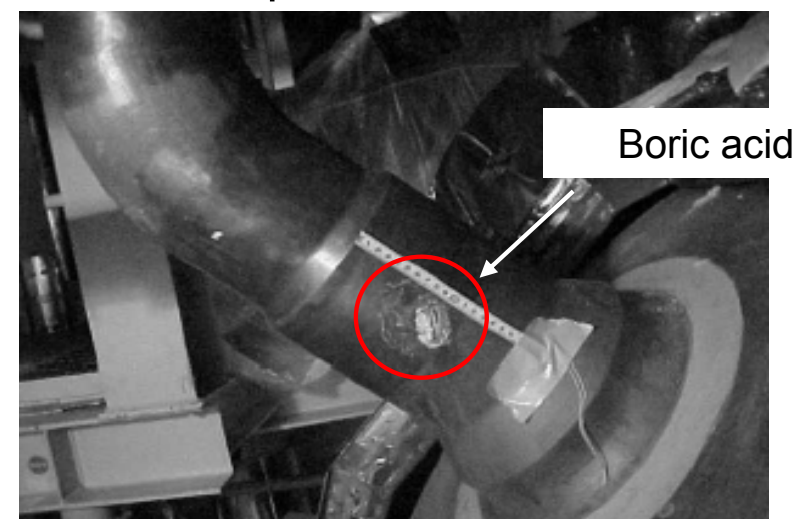
Safe-end Weld

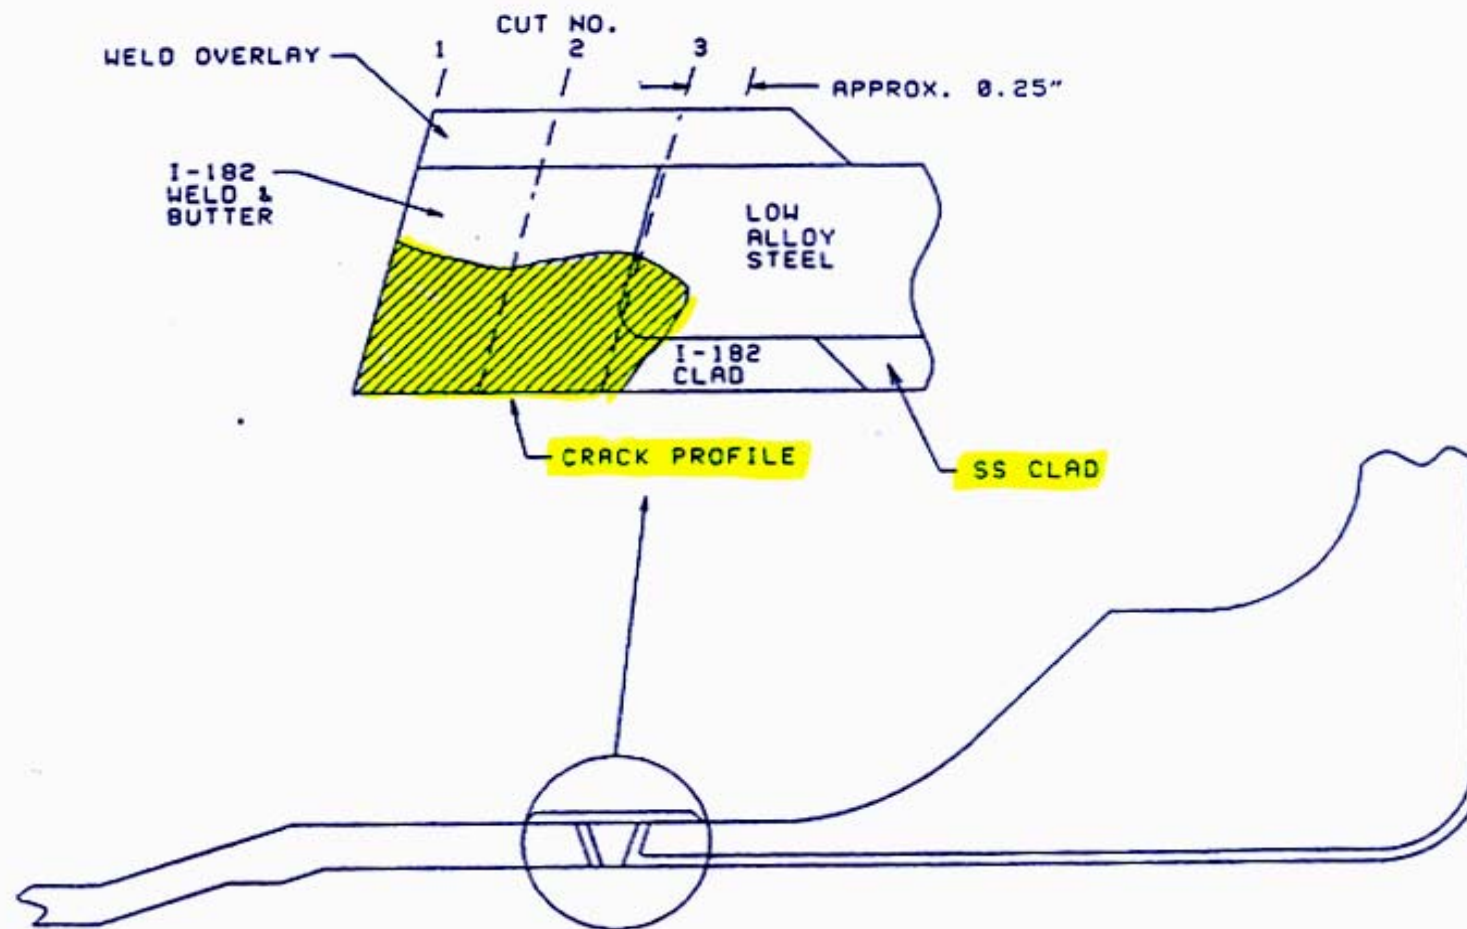
Fig. 3. Crack profile – Chinshan 2 N2E nozzle (recirculation inlet).

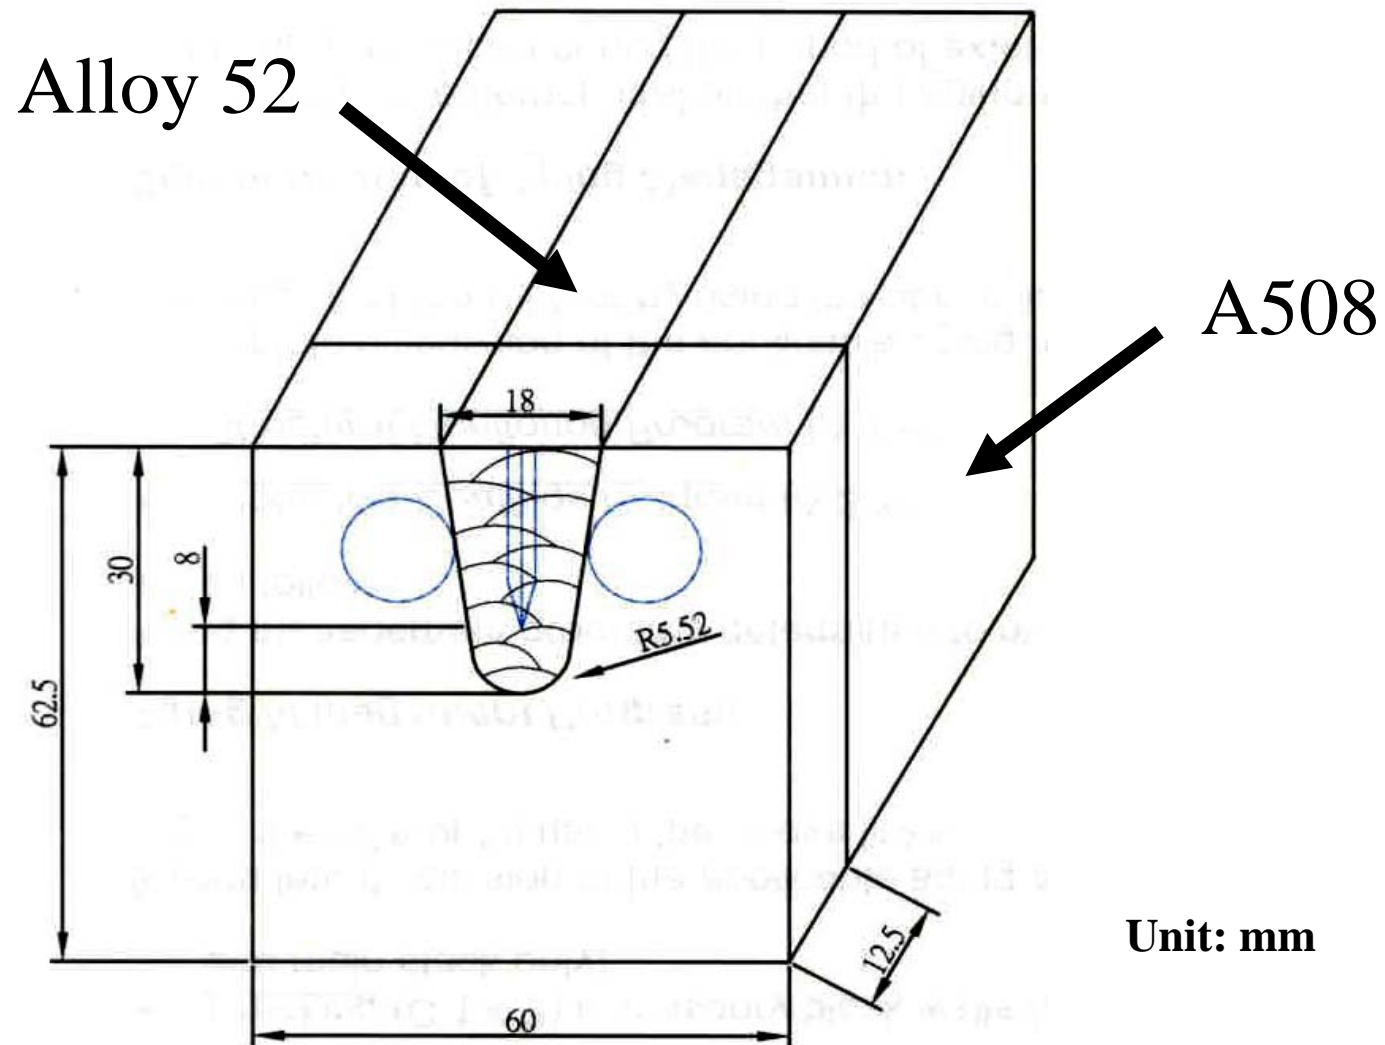
Sampling scheme for the dissimilar metal weldment

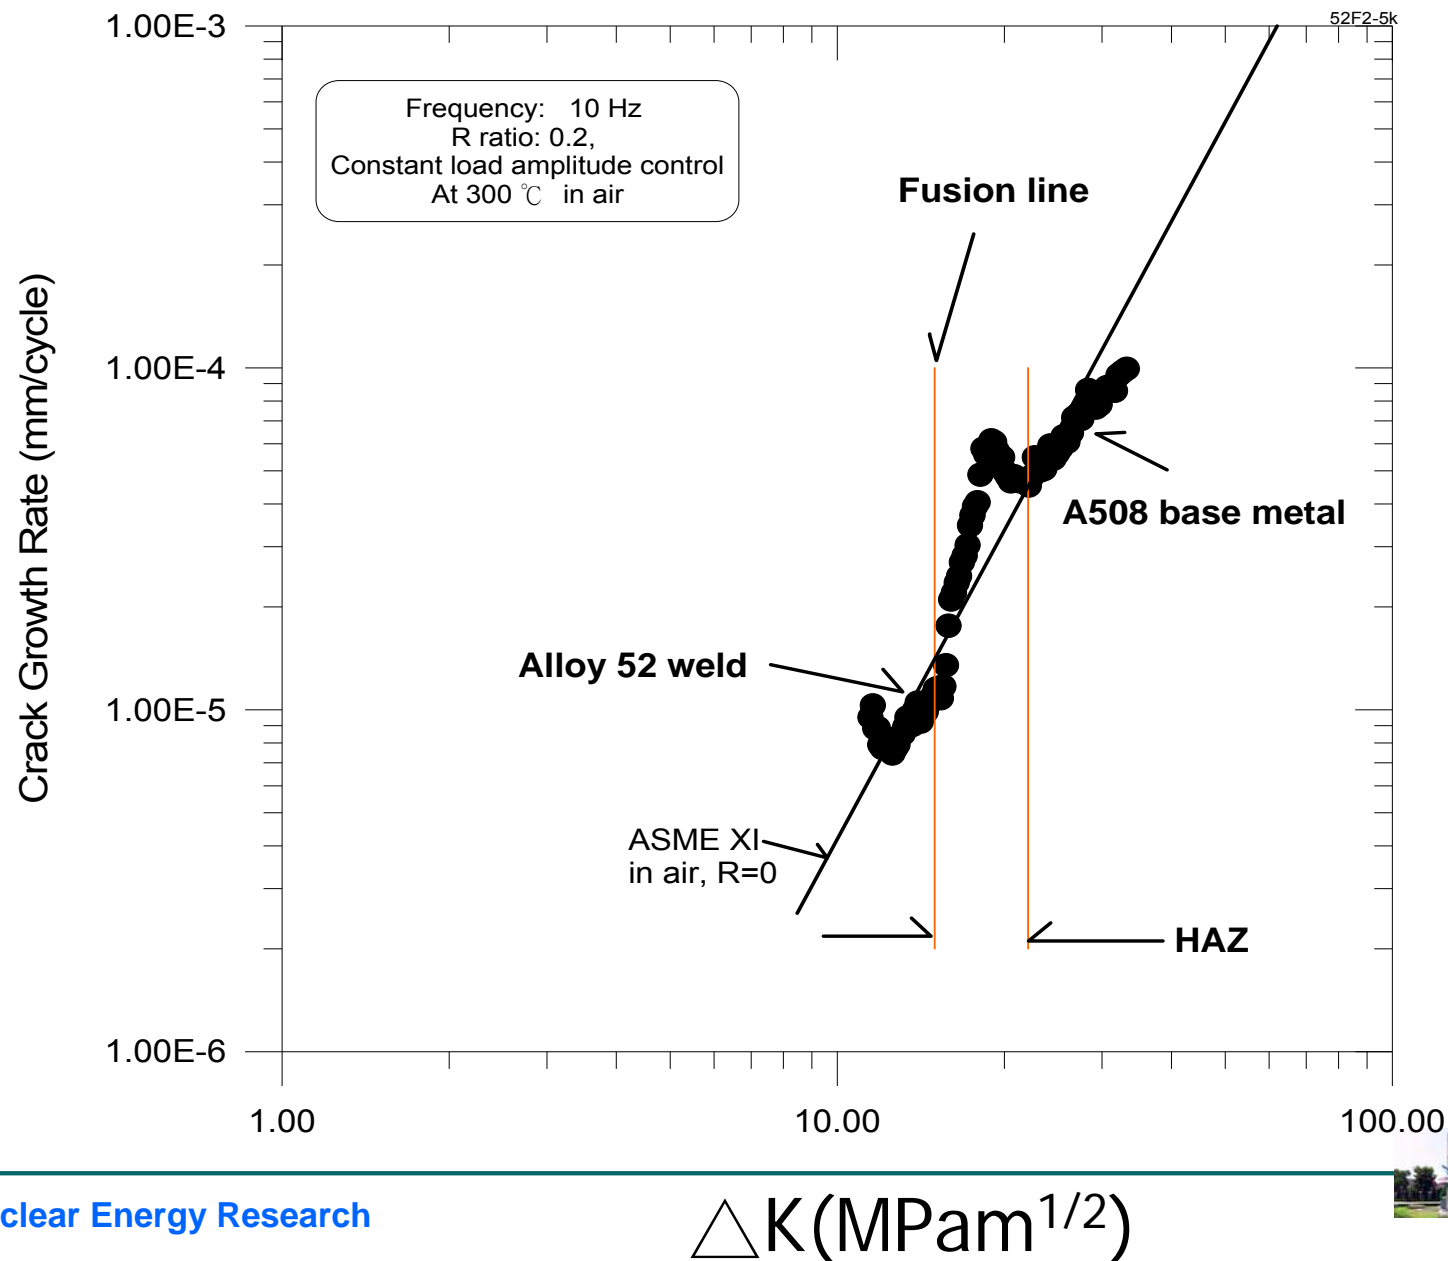
Fatigue crack growth rate against stress intensity factor range for Alloy 52-A508 weldment tested at 300°C in air

Fatigue crack growth rate **overshoot** in the HAZ. It could be related to the **residual stress, higher hardness and complicated microstructure.**

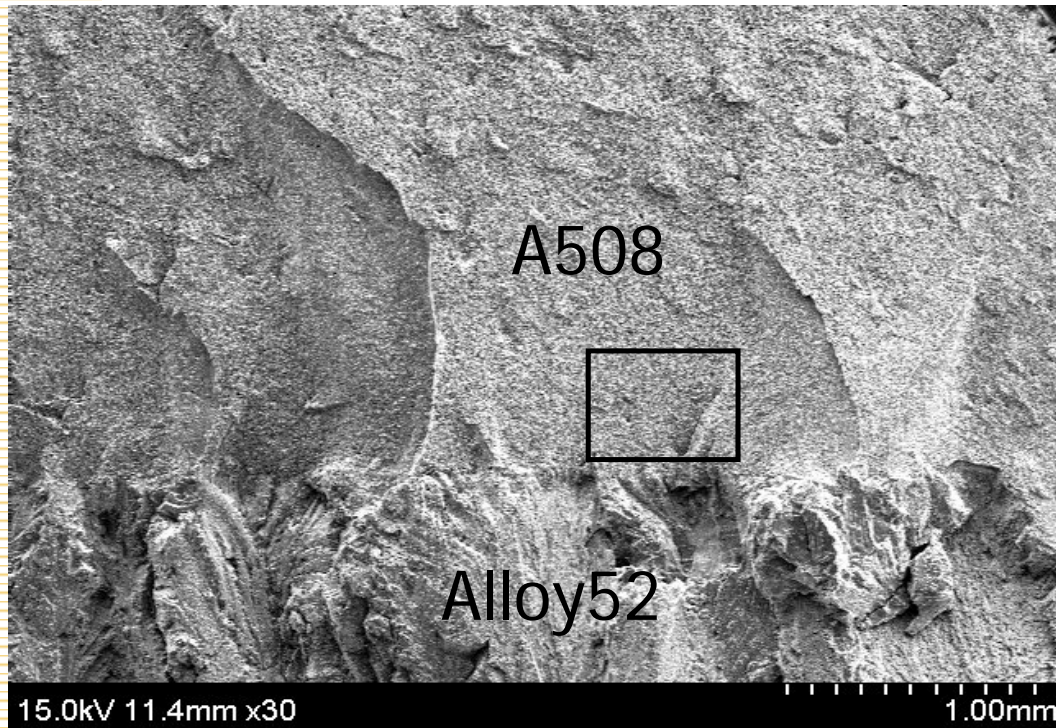
Fatigue fracture surface of Alloy 52-A508 weldment

(a) macroscopic fracture surface showing the **quasi-cleavage-like surface** of the heat-affected zone

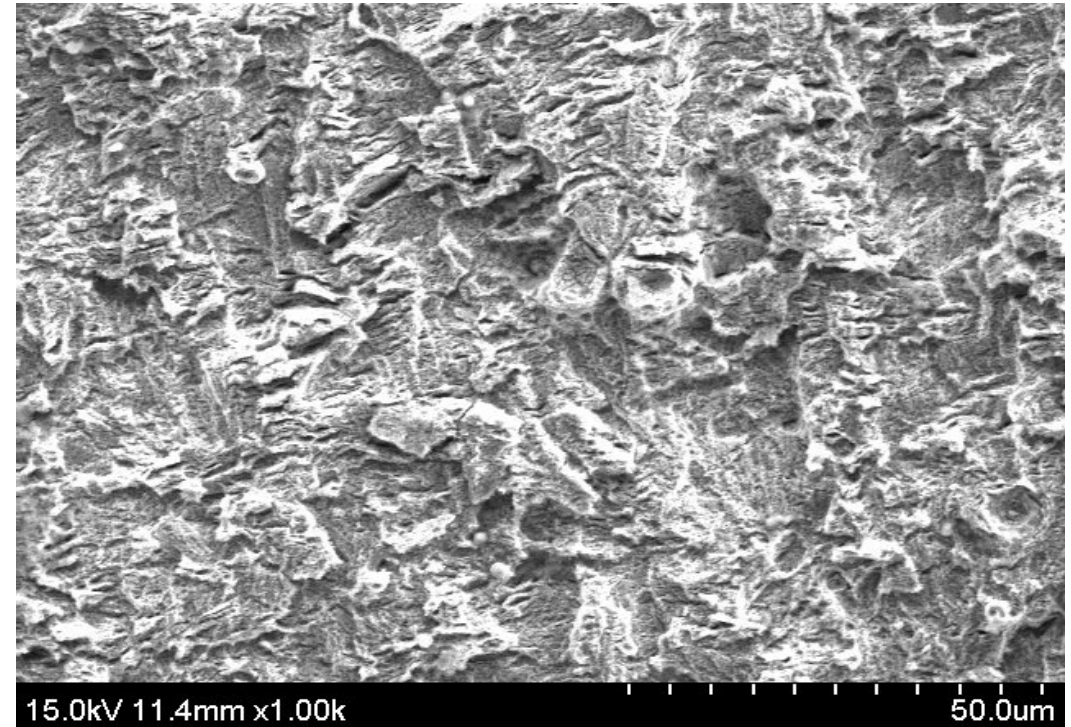
(b) showing **brittle striations** at a higher magnification.

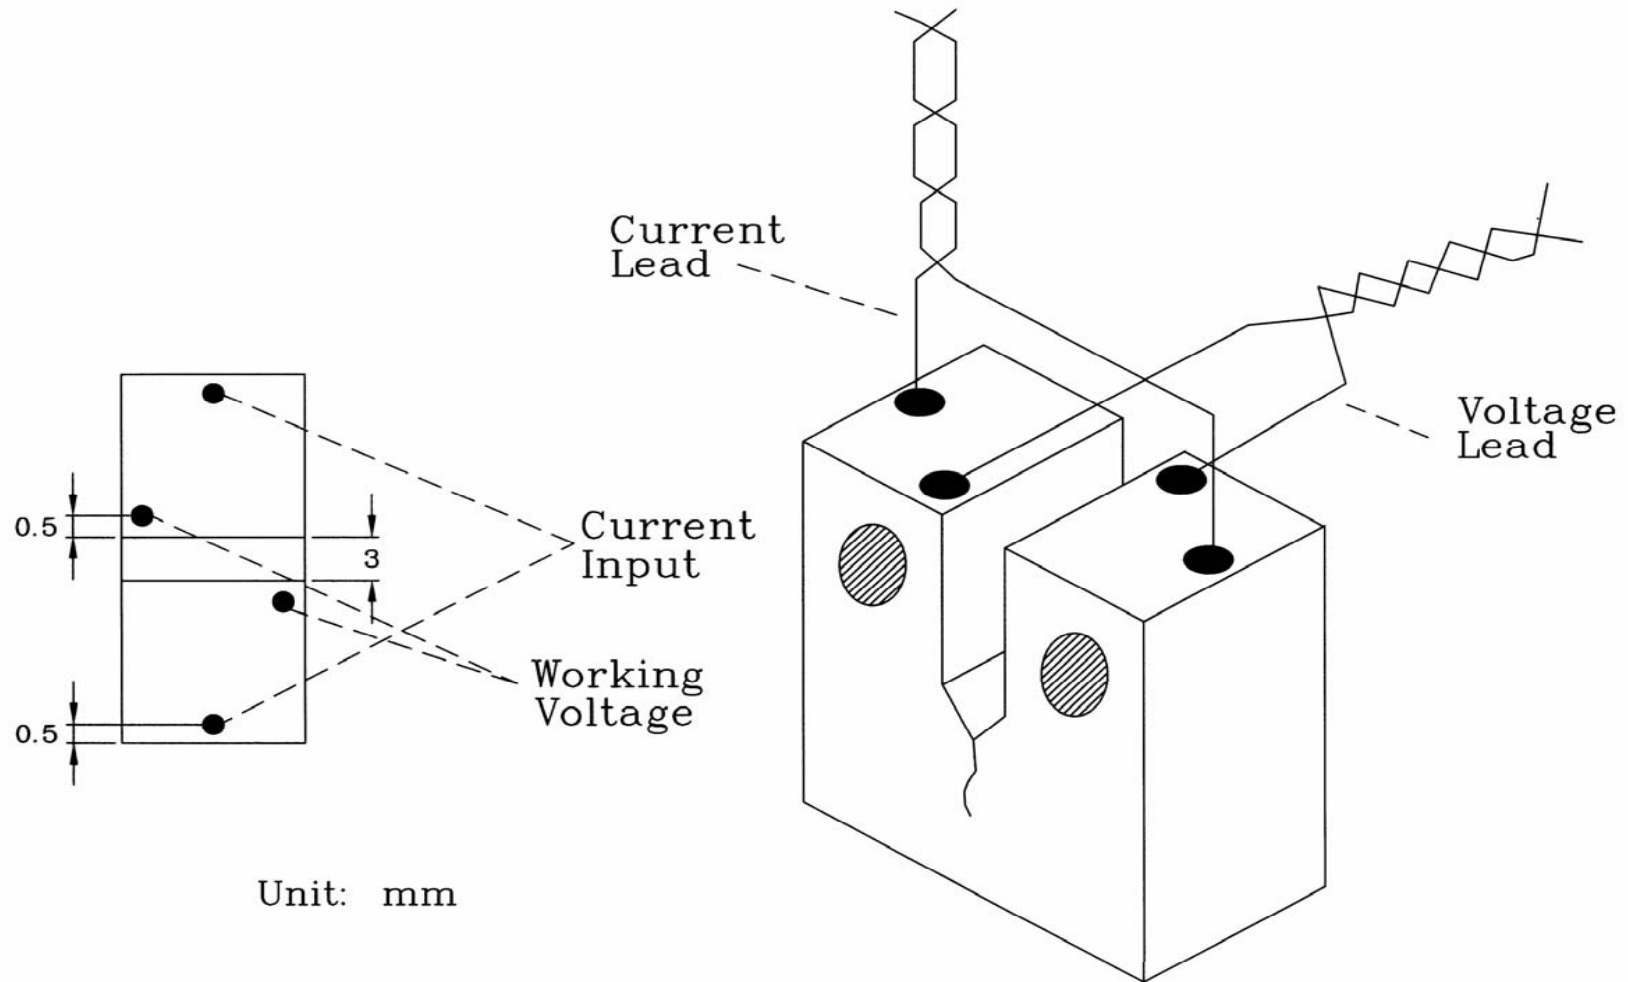
A schematic disposition of the ACPD probes

Unit: mm

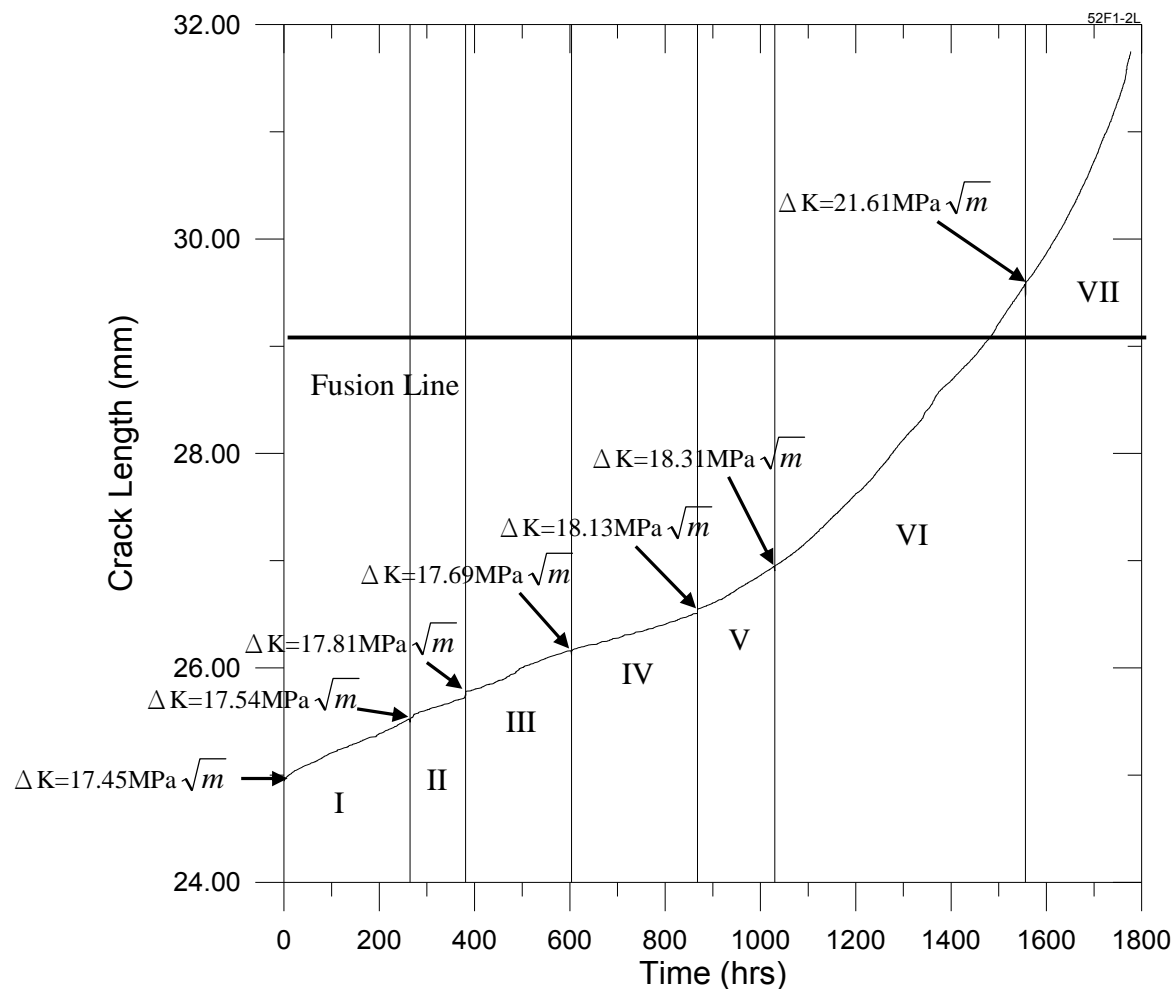
Fatigue crack growth behavior of Alloy 52-A508 specimen without a side groove on each side in the high temperature water environment.

Unit: mm/sec

I	II	III	IV	V	VI	VII
5.79×10^{-7}	5.78×10^{-7}	4.72×10^{-7}	4.01×10^{-7}	6.95×10^{-7}	1.35×10^{-6}	2.87×10^{-6}

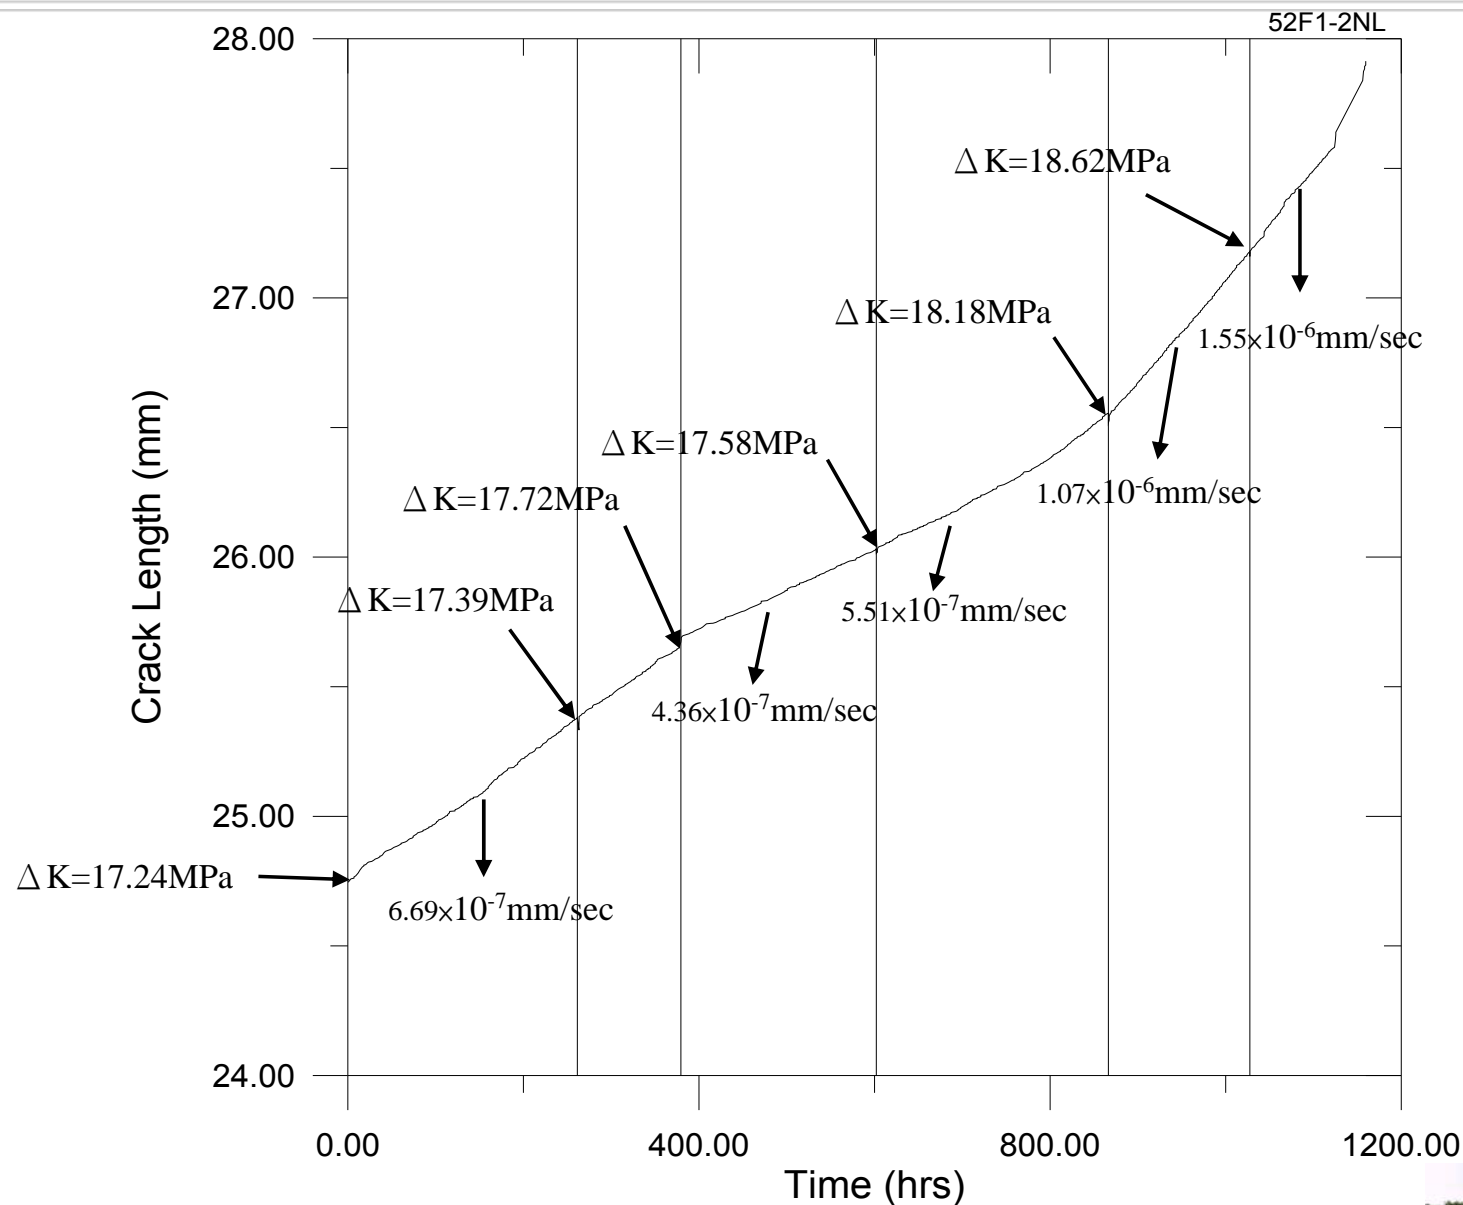
Fatigue crack growth behavior of Alloy 52-A508 specimen **with a side groove on each side** in the high temperature water environment.

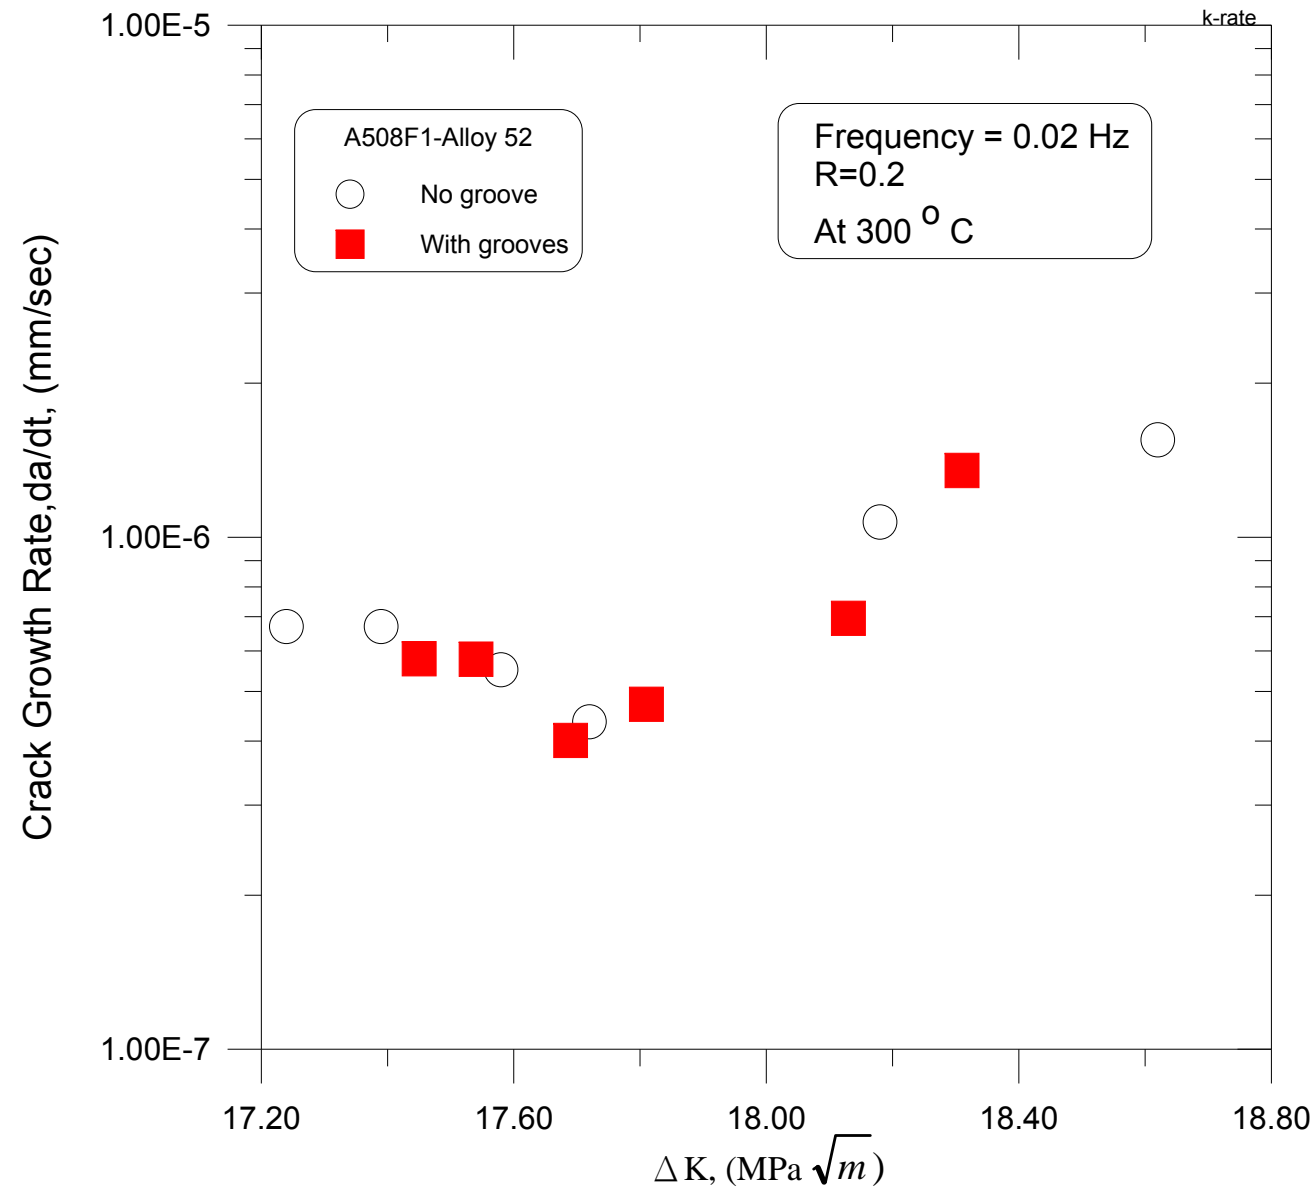
A comparison of fatigue crack growth behavior for Alloy 52-A508 weldment with and without groove in high temperature water environment.

Corrosion fatigue crack growth rates increasing with the crack advance might be due to

- 1) An increase in the **tensile residual stress** and a decrease in **crack closure** effects in the Alloy 52 weld.
- 2) **Macro-composition transition** from the bottom to the center of the weld.

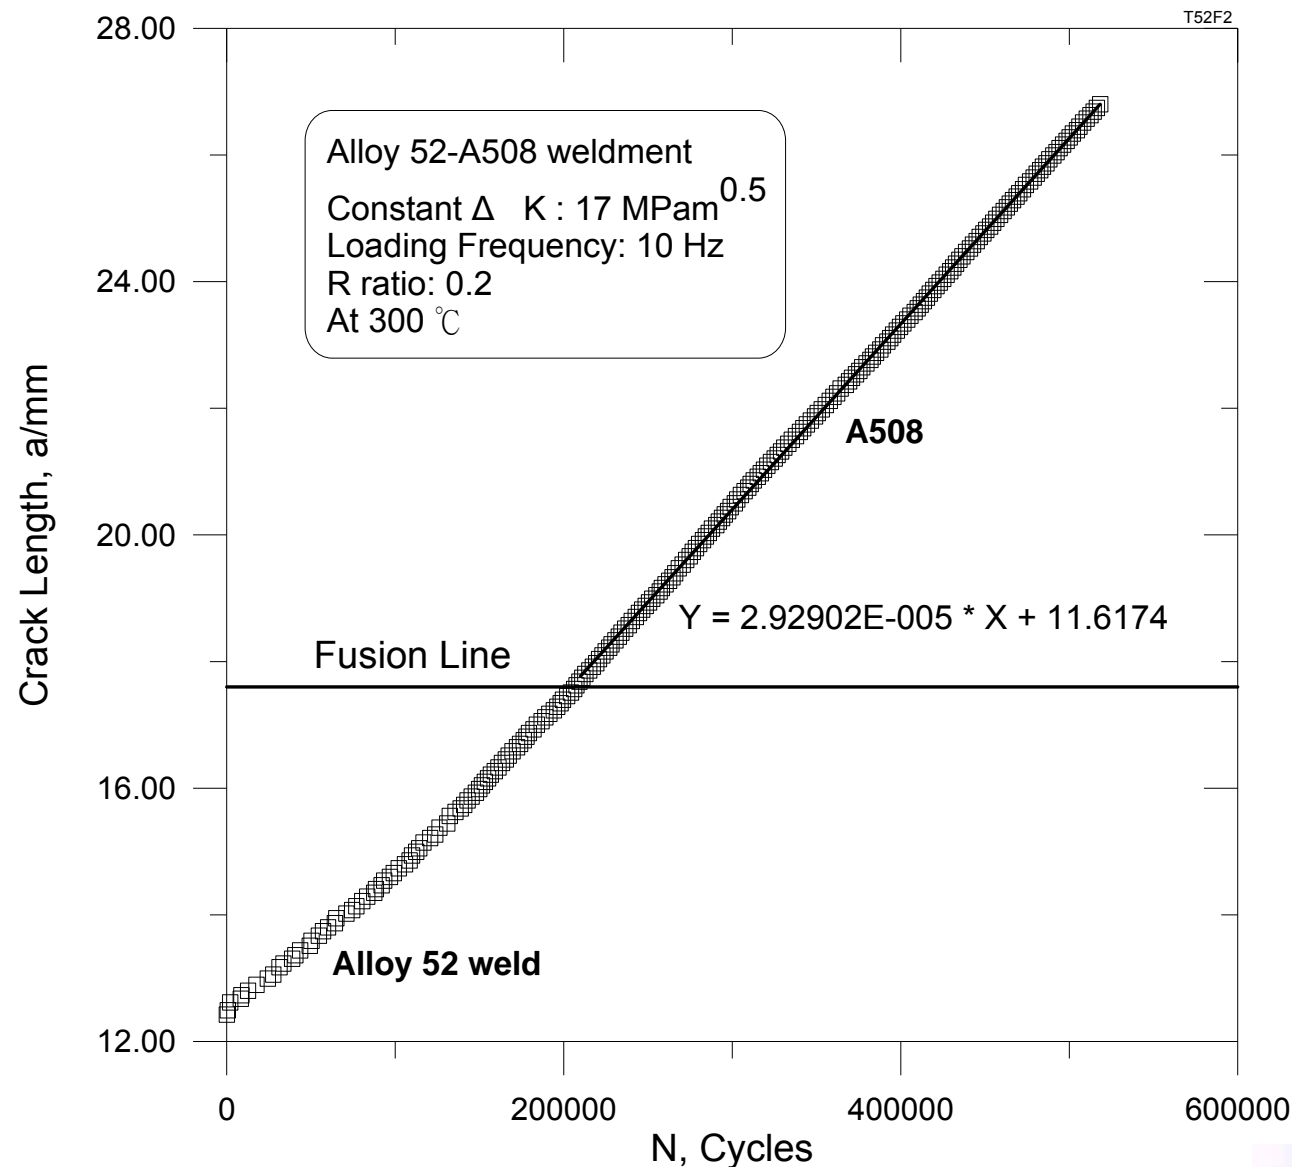
Alloy 52-A508F2異材銲道於300℃空氣中 定應力強度因子之裂縫生長曲線圖

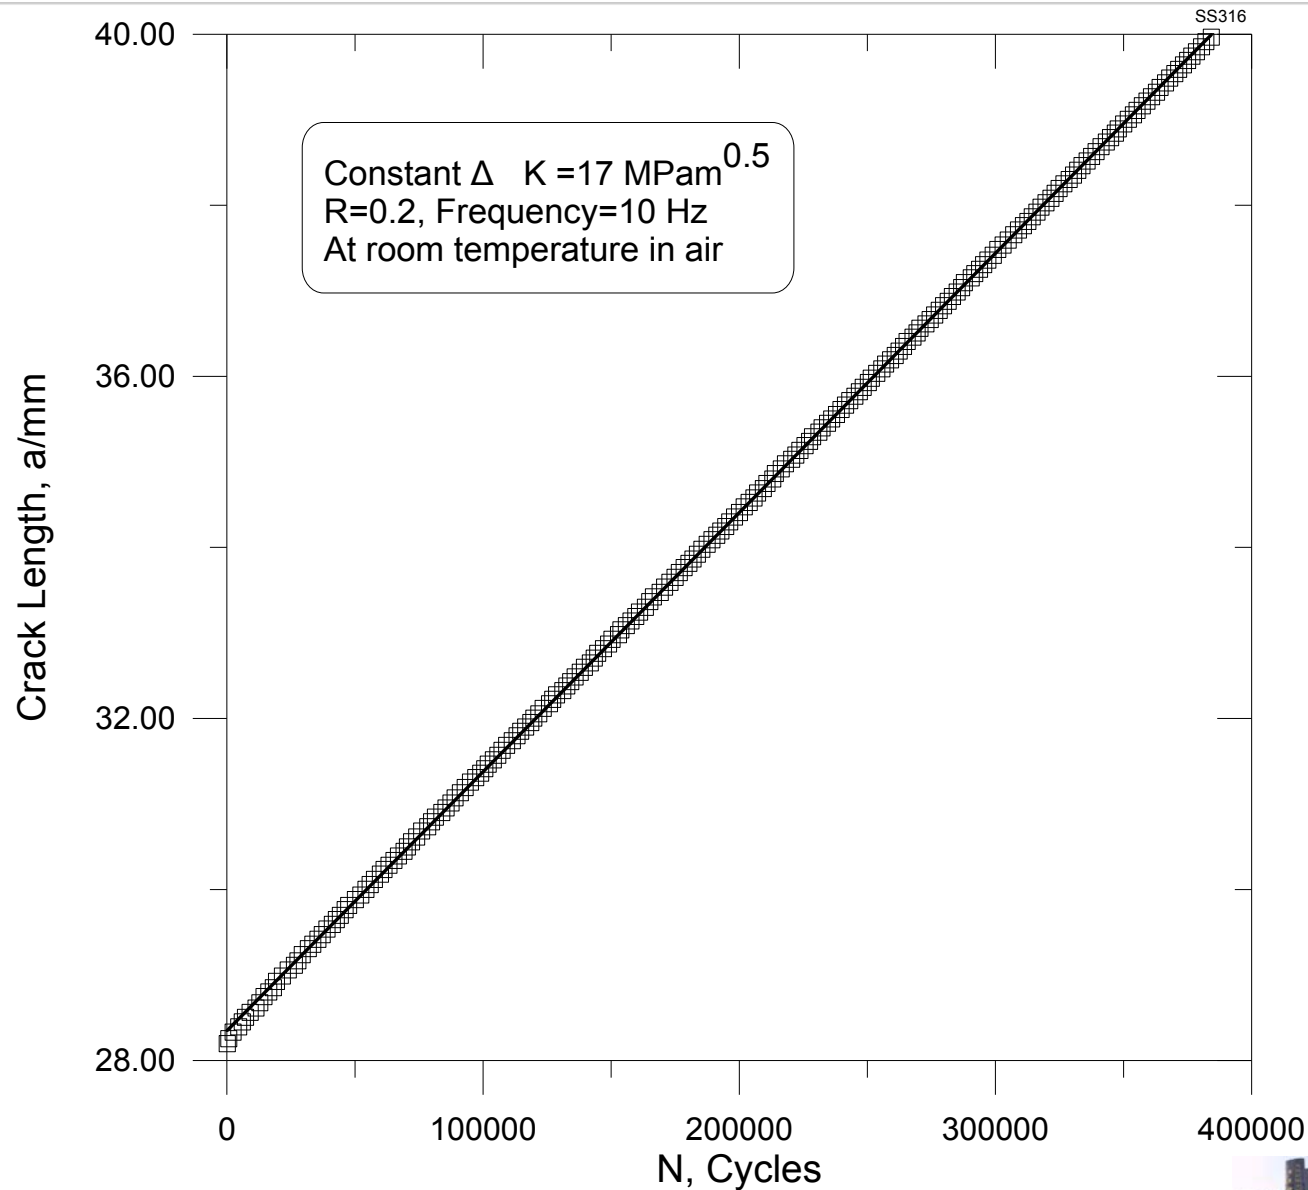
SS316L 於室溫空氣中定應力強度因子之 裂縫生長曲線圖

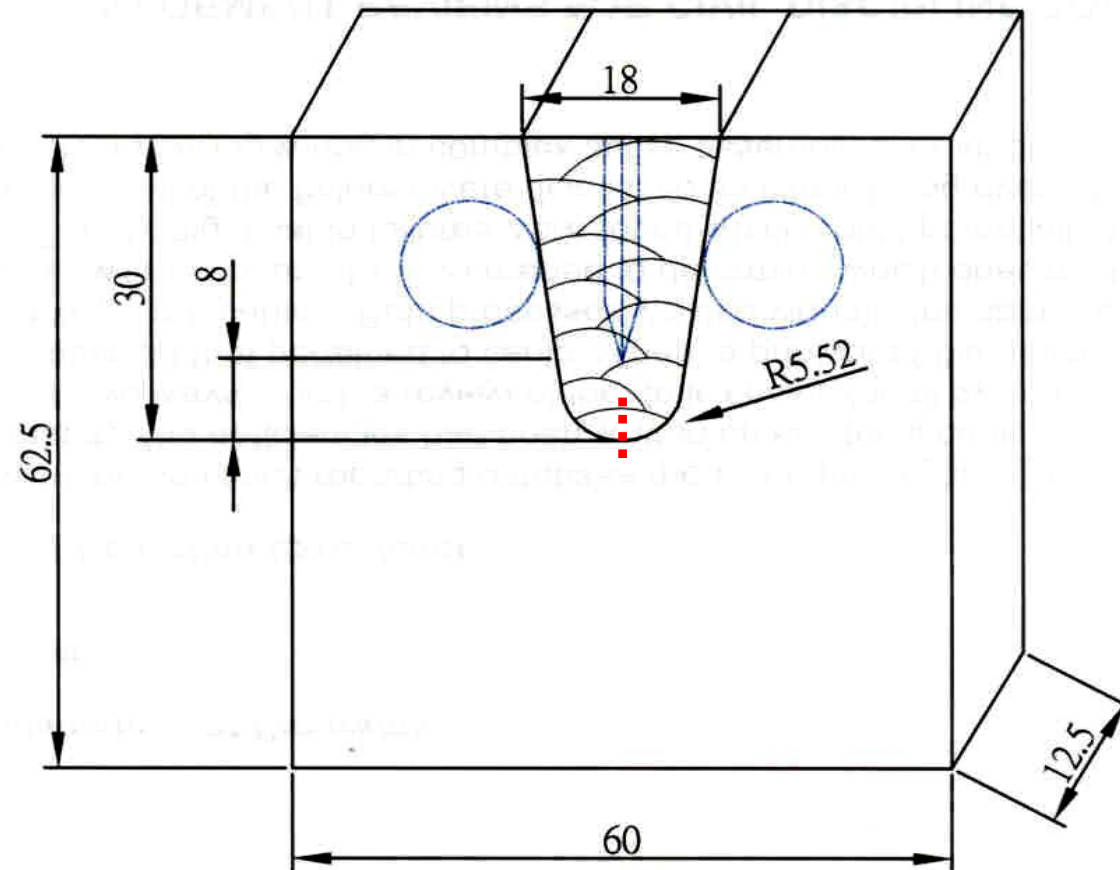
Residual stress measurement in front of the specimen notch

Unit: mm

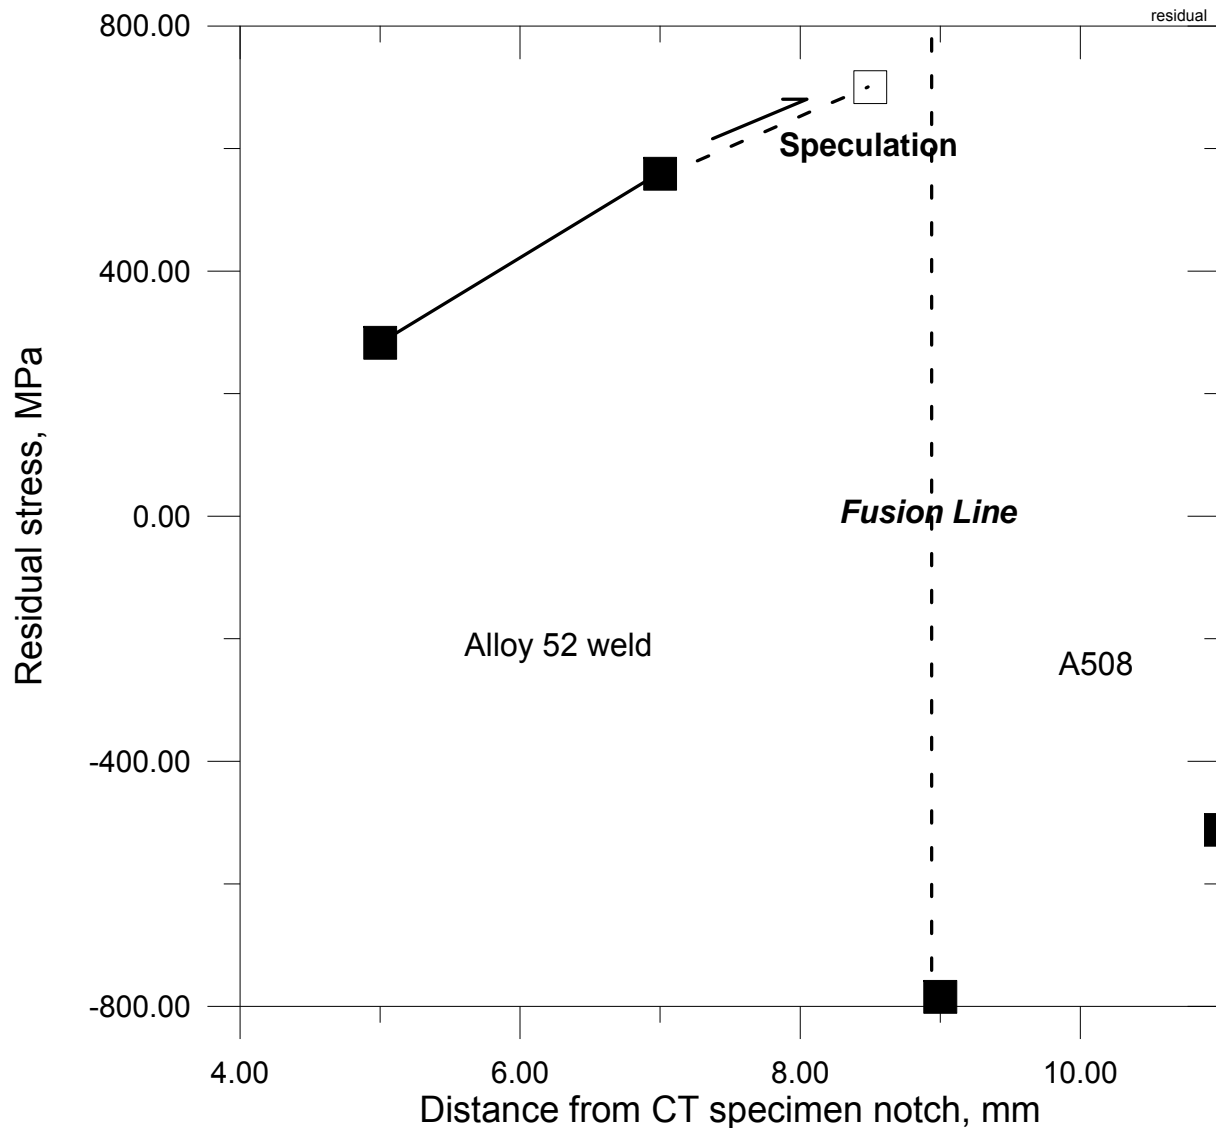
Residual stress measurement in front of the specimen notch

An increase in the residual tensile stress with the weld depth

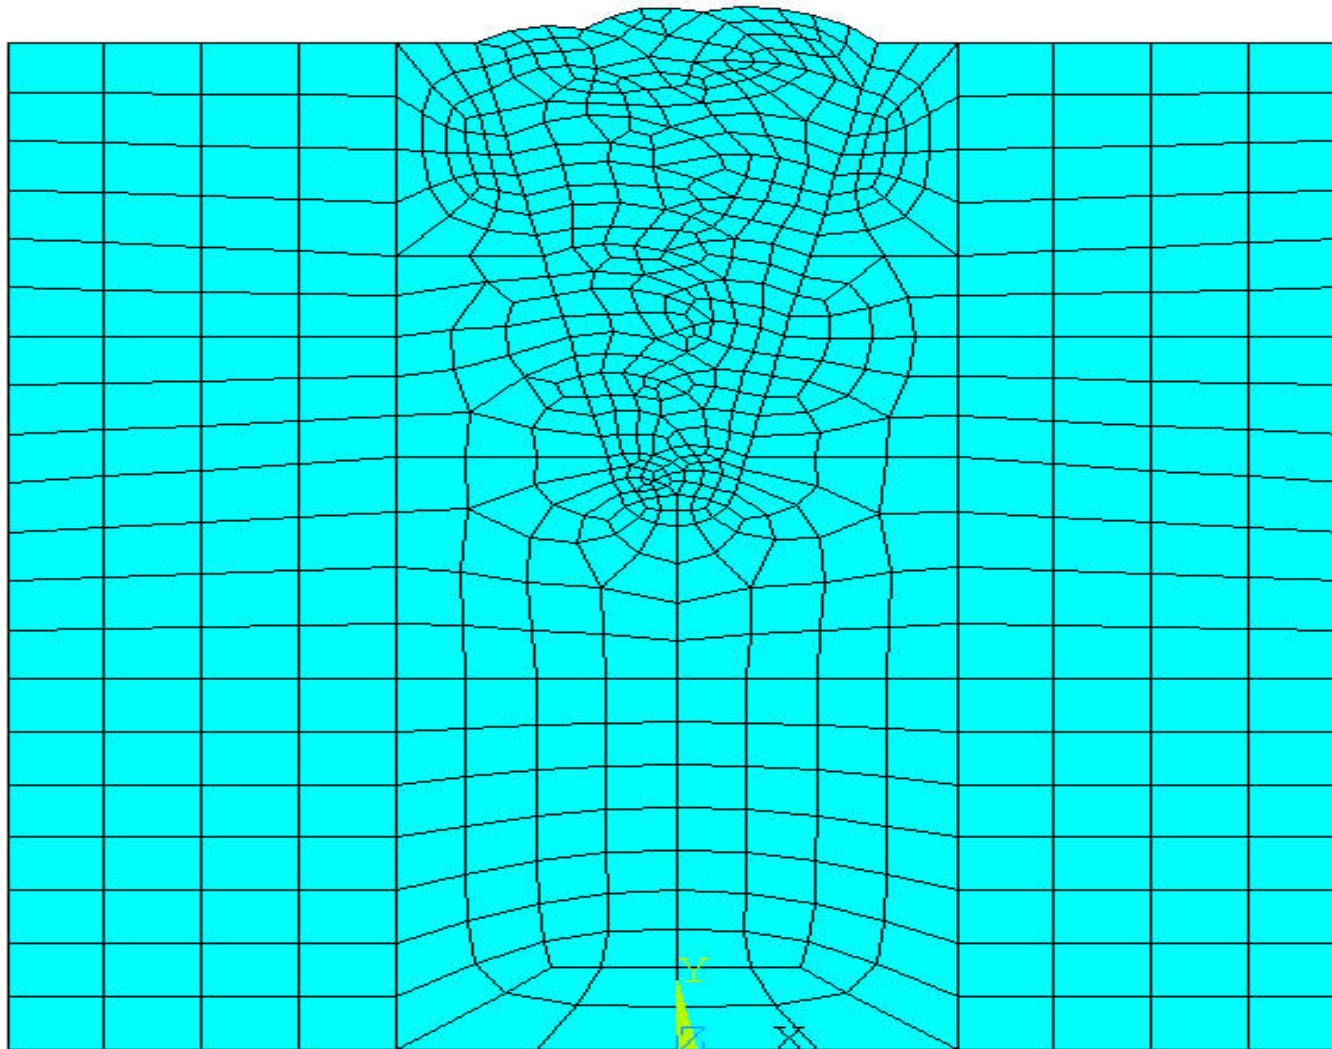
FEM model for the Alloy 52-A508 weldment.
