沸水式反應器壓力邊界異材銲道 腐蝕疲勞行為研究

2009中華核能學會年會暨用過核燃料管理策略研討會

核能研究所

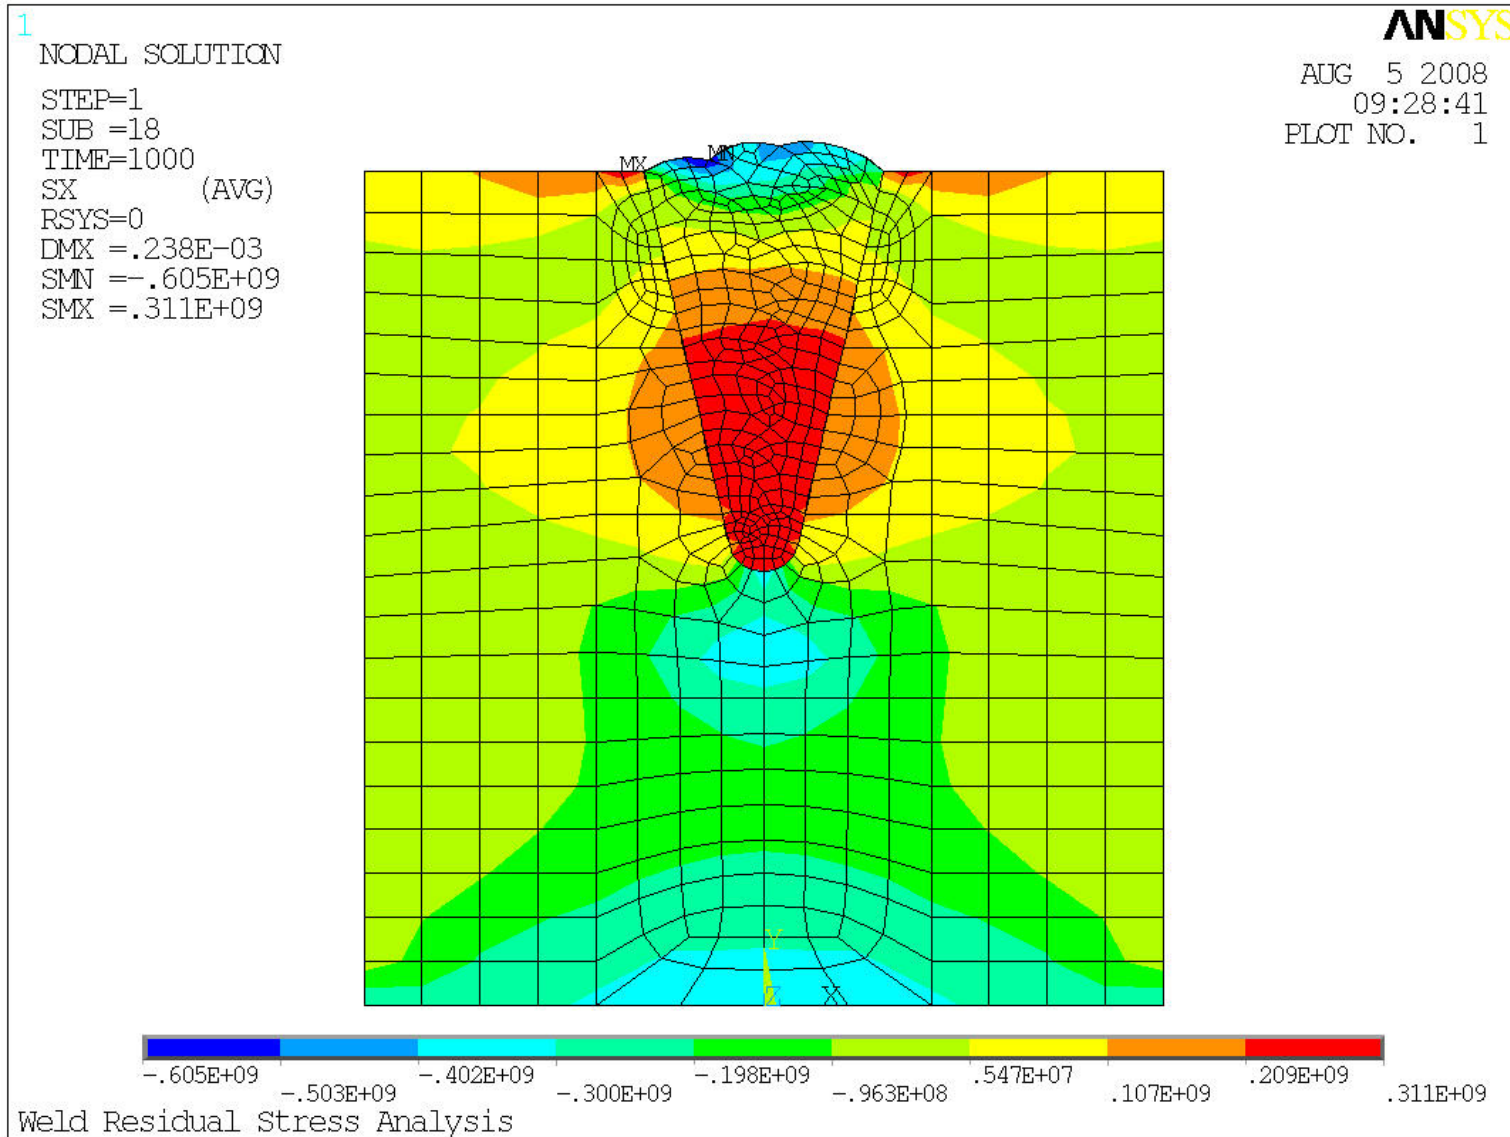
Welding residual stress distribution for Alloy 52-A508 weldment.

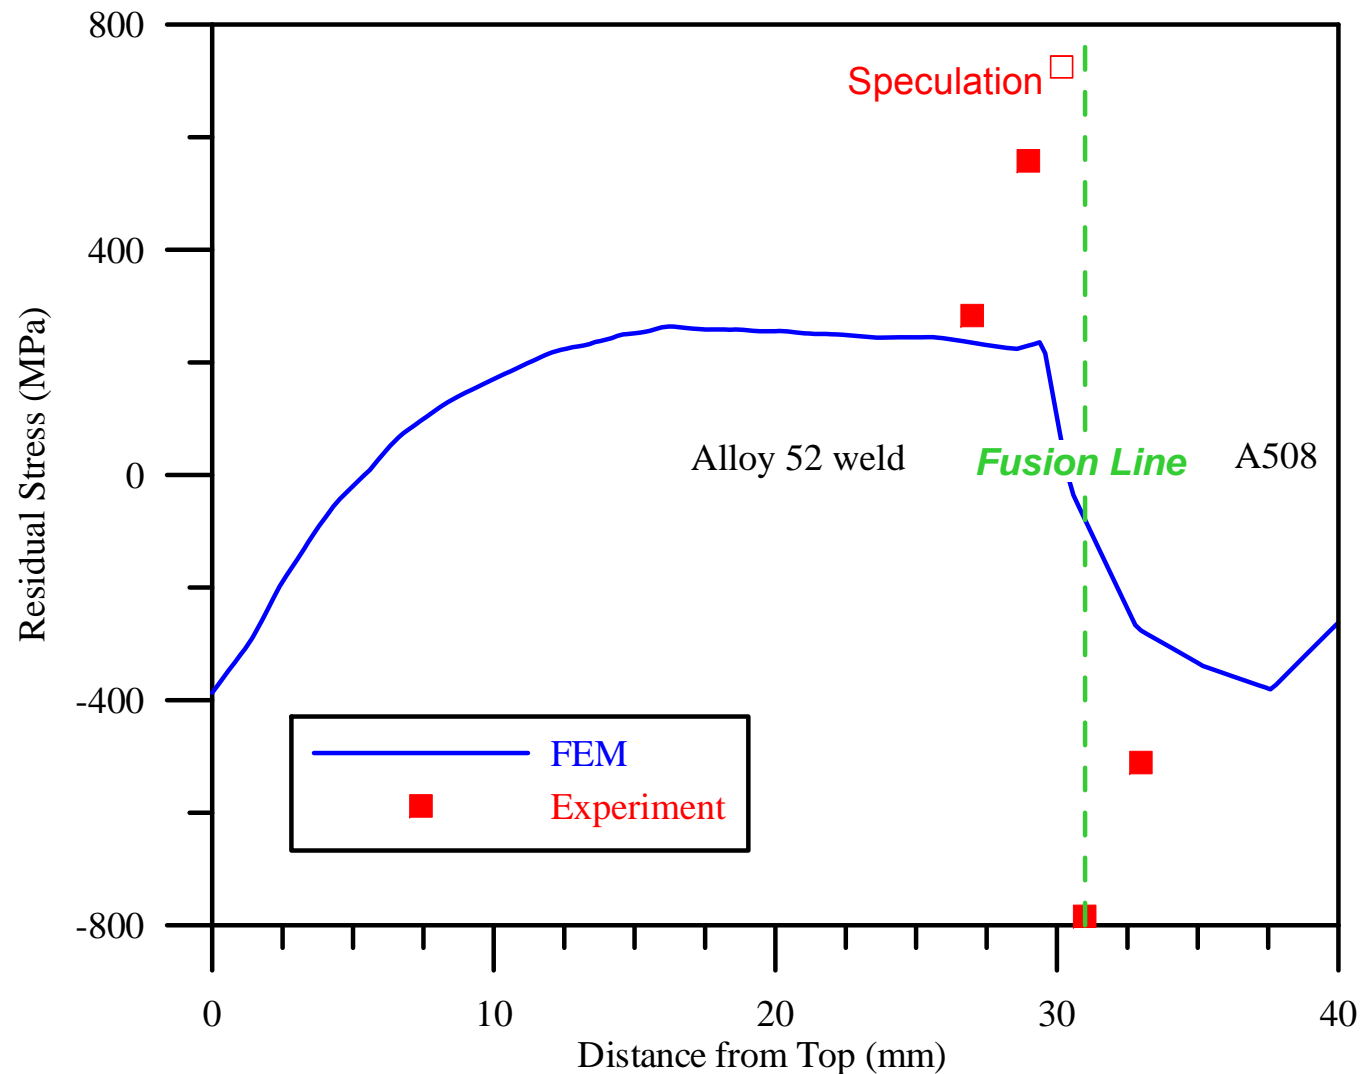
A comparison between analytic results and experimental measurements on the welding residual stress.

- 1) Corrosion fatigue crack growth rates for the dissimilar metal weldments were observed to **increase with crack advance** under the nominal constant ΔK loading mode. This could be due to the effects of **an increase in the tensile residual stress** and **a decrease in the crack closure** in the Alloy 52 weld.
- 2) The tensile residual stress measured by **a hole-drilling strain gauge method** increased with the weld depth. The trend of stress distribution by numerical analysis agrees well with that for the experimental results.

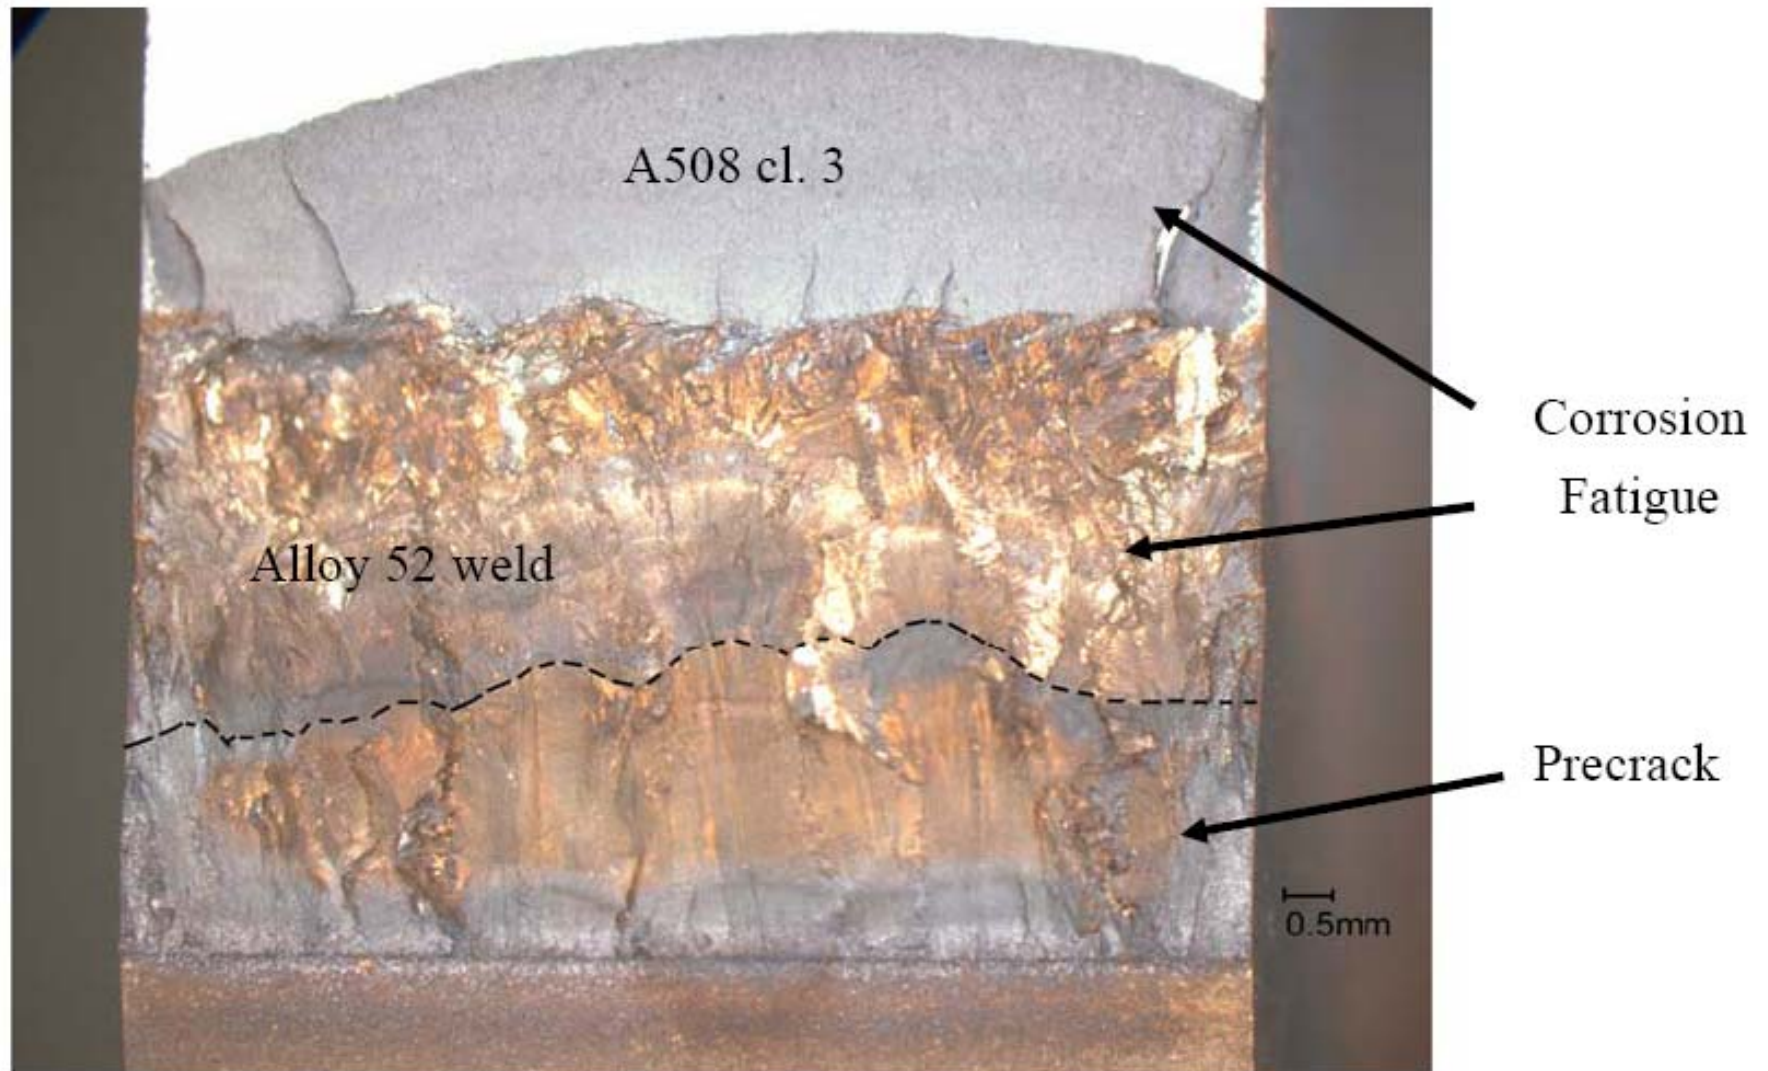
Fracture surface of Alloy 52-A508 weldment at a loading frequency of 0.02 Hz in a simulated BWR water environment.

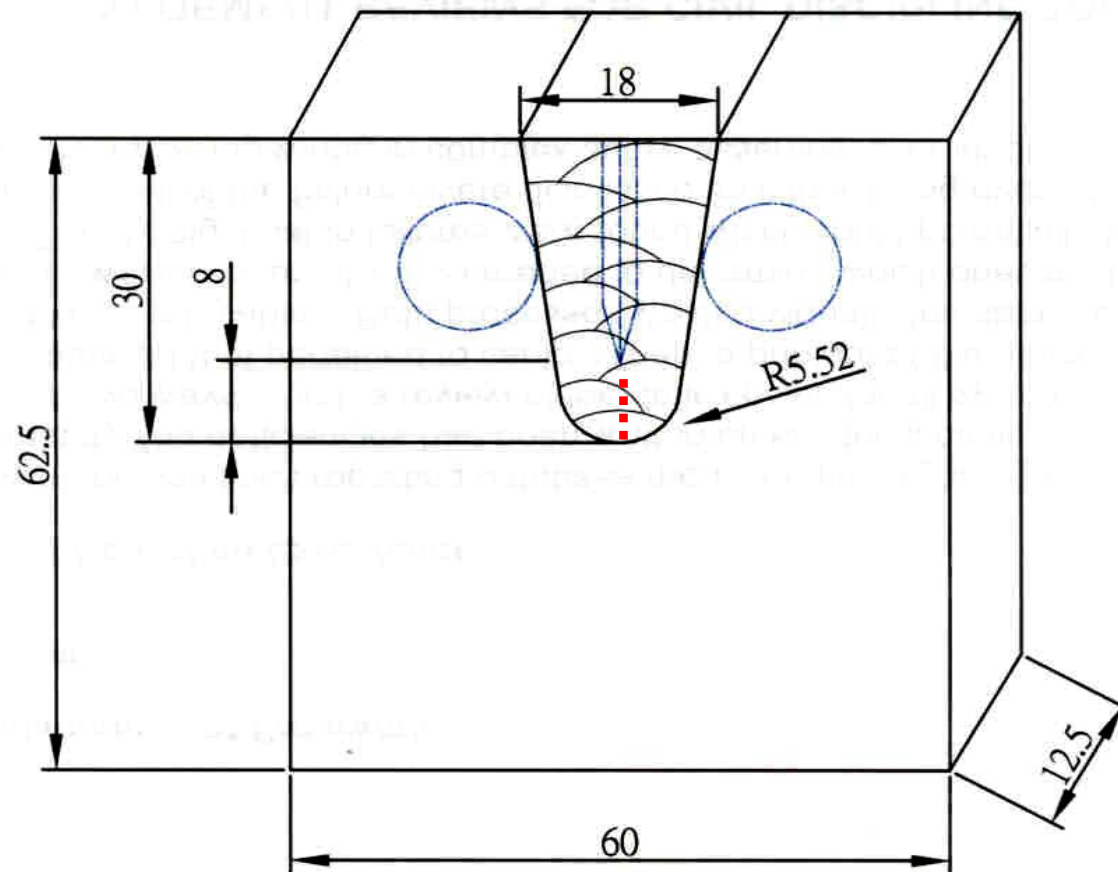
Fatigue crack closure measurement in front of the specimen notch

Unit: mm

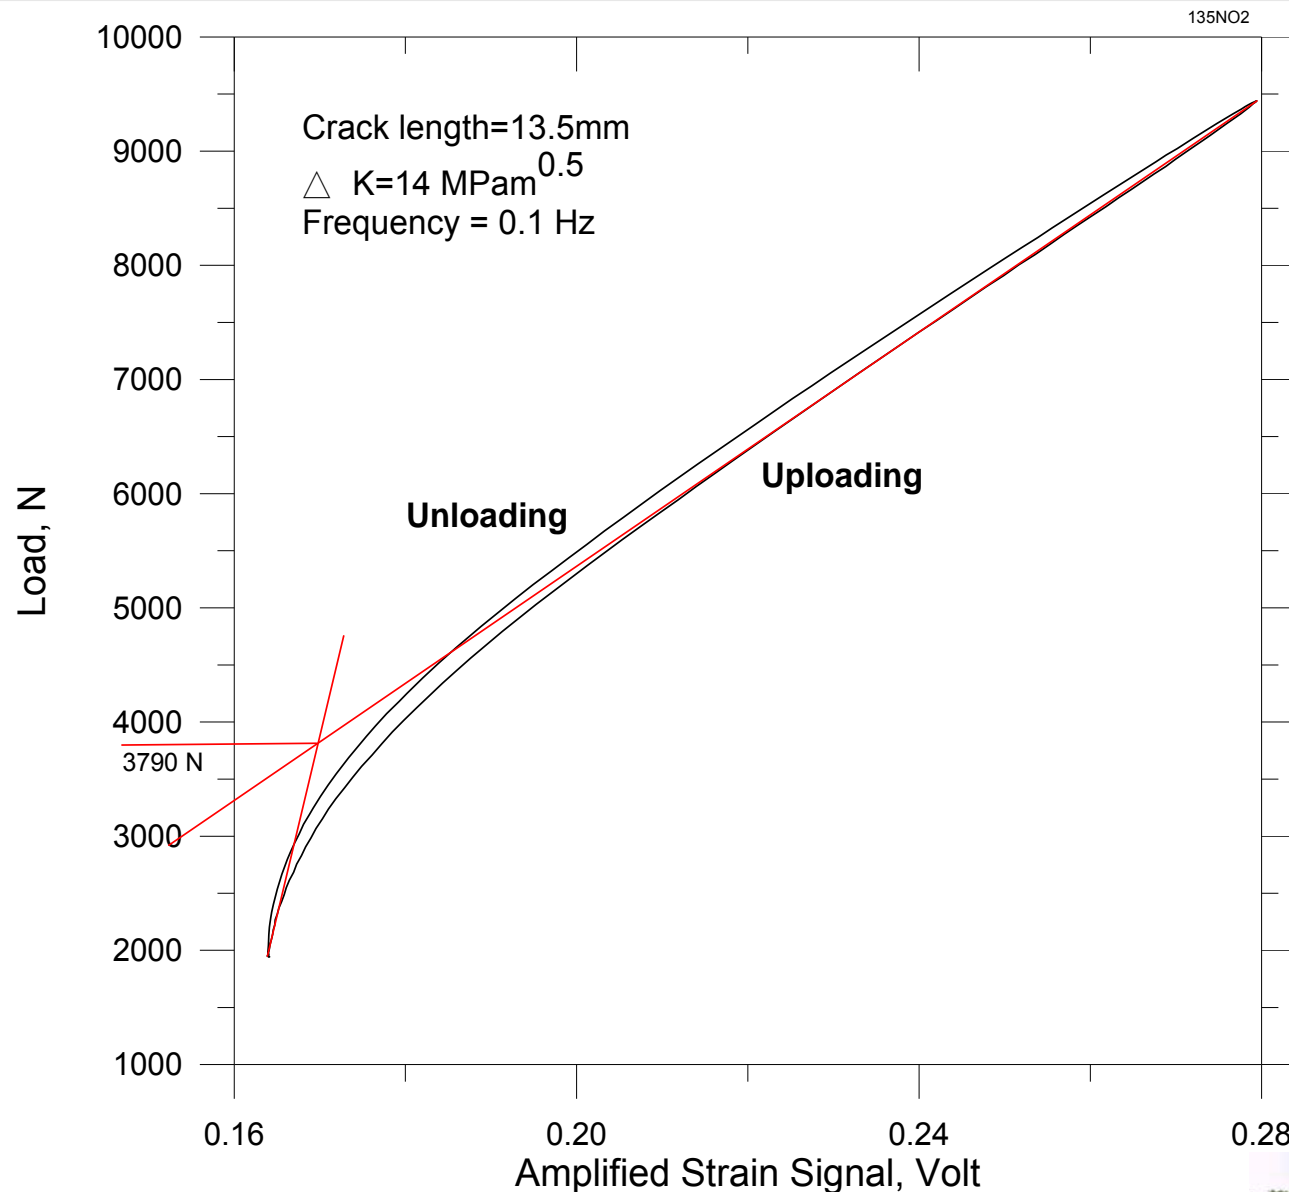
Crack opening stress intensity factor, K_{op} , was determined by the intersection of the two secants of unloading curve.

$$\Delta K_{\text{eff}} = \Delta K_{\text{max}} - \Delta K_{\text{op}}$$

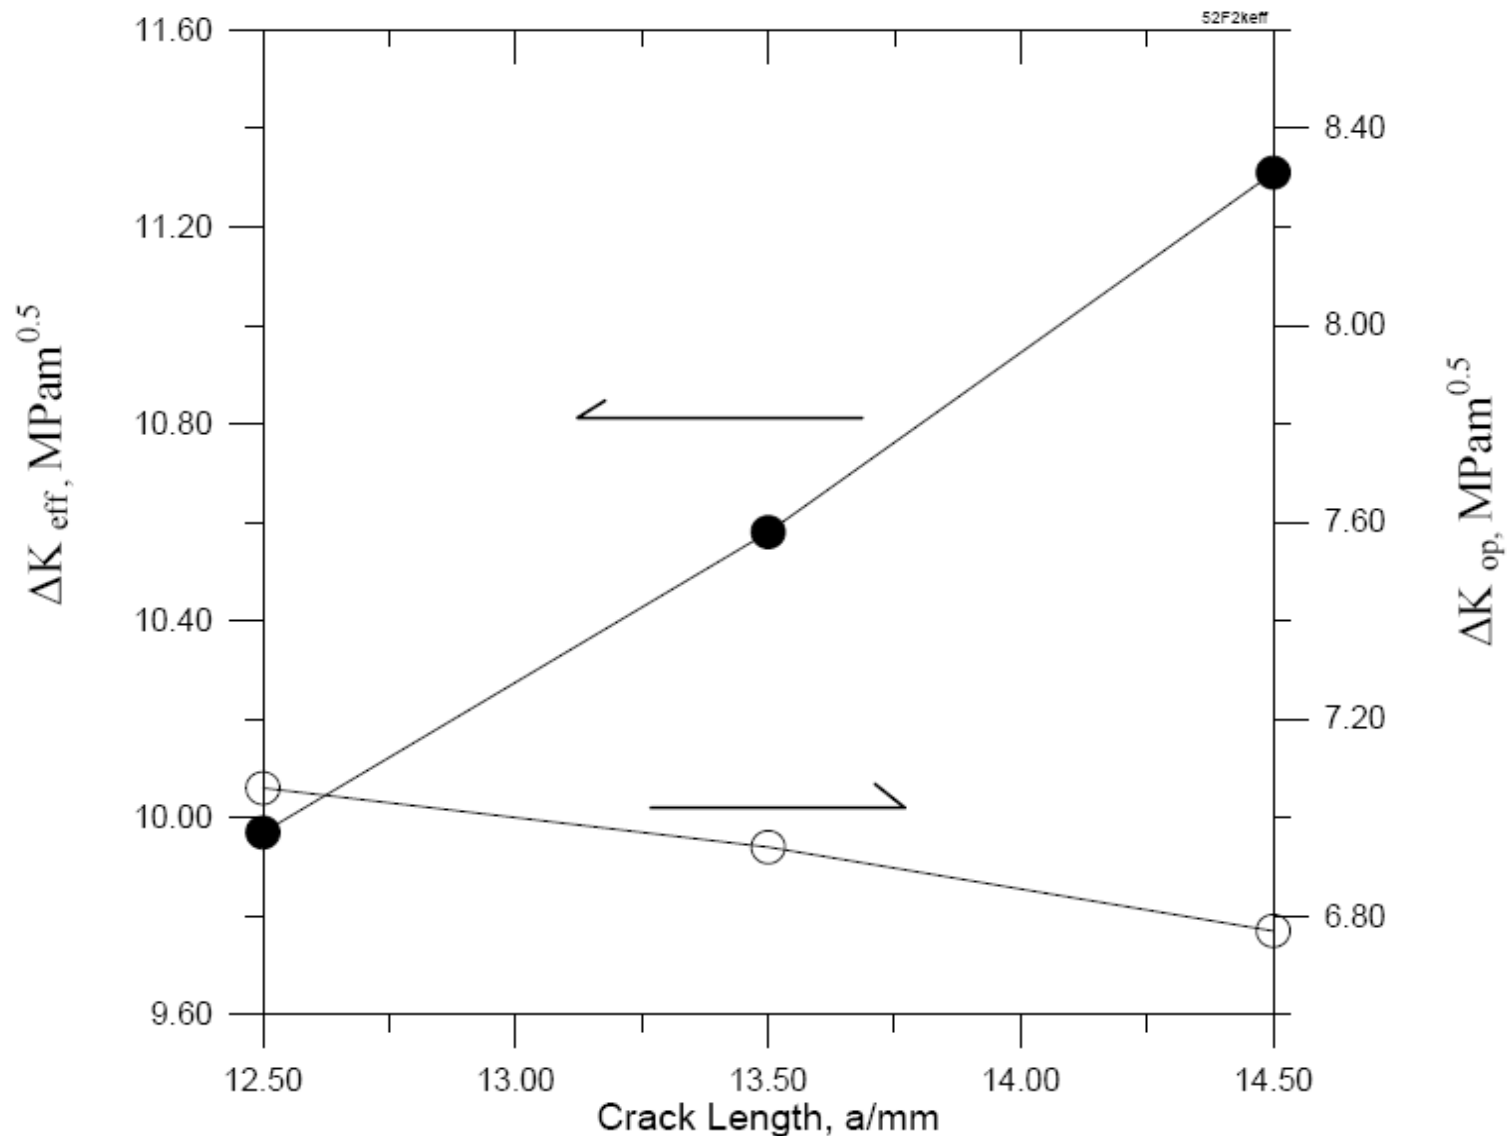
The crack closure evolution along the crack length in the weld.

- 3) The crack closure effects in the weld were verified to **decrease with the crack advance** measured by the strain gauges ahead of the crack tip.

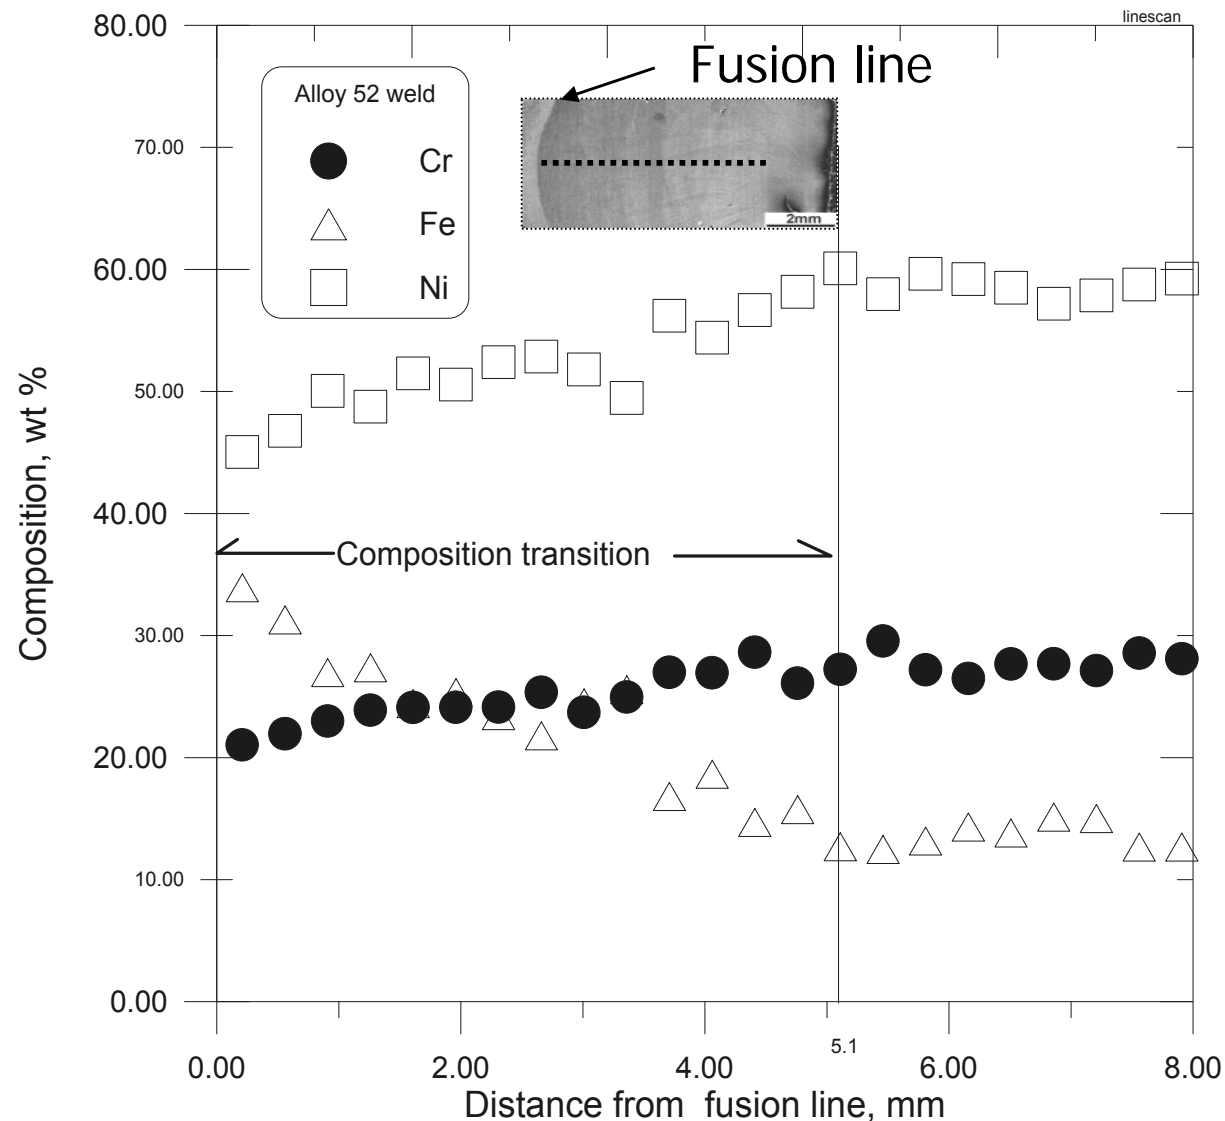
Macro-composition transition from the bottom to the center of the weld.

- 1) An increase in the **tensile residual stress** and a decrease in **crack closure** effects in the Alloy 52 weld.
- 2) **Macro-composition transition** from the bottom to the center of the weld.
