核能電廠地下管線問題探討

行政院原子能委員會
核能管制處 方 鈞

中華民國98年12月16日

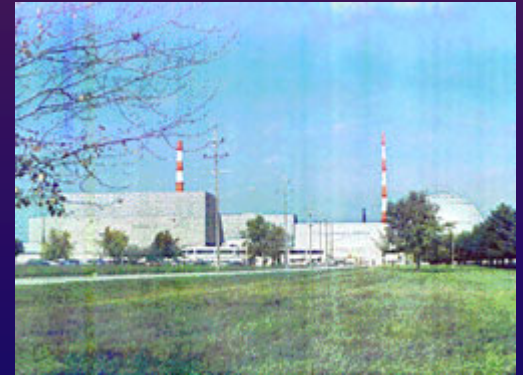
2006年2月10日 Exelon公司的Dresden電廠通知NRC地下水監測井測到增高的氚，此監測井臨近一地下管路，此管路係從CST通往HPIC，以往在2004年CST通往HPIC的管路曾發現有洩漏，管路175呎長其中75呎長在2004年被更新過，電廠懷疑此次洩漏是在未更新的100呎管路部分。2006年2月11日的水樣氚濃度為486,000pCi/L, 2月13日的樣品為529,000pCi/L，2006年2月11日電廠將此管路隔離，計畫洩水檢修此管路。

冷凝水槽(CST)
通往高壓注水系
統(HPCI)地下

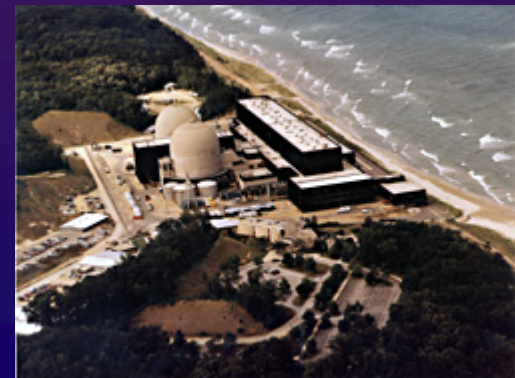
2008年9月20日 Indiana/Michigan公司的D. C. Cook 1號機，20:05因主汽機高振動手動停機，當時主發電機發生火災，消防水系統隨即起動，但不久消防集管壓力逐漸下降，雖然所有消防泵均起動，仍無法維持集管壓力。20:20消防水槽低水位警報出示，20:28重新配置管路從另一個消防水槽取水，發現大量消防水從地下管線流失，故隔離消防管線洩漏區域，方才回復正常。

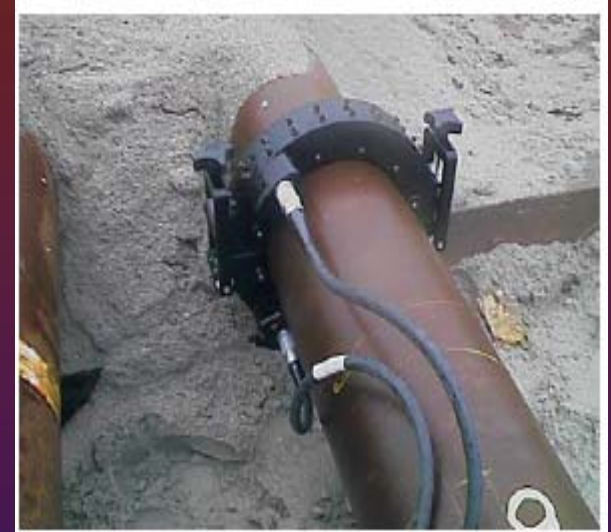
- ❖ Bulk Wave發射於充水管路時，會快速衰減，但 Guided Wave 不受影響（有Coating/Liner管路亦然）
- ❖ Guided Wave可用於檢測 Service Water Piping

- ❖ Ongoing Inspection Methods Research : Guided Wave NDE /Large & Intermediate Diameter Pipe NDE Inspection Vehicle
- ❖ Proposed/Planned Inspection Methods Research : 10 in & smaller Inspection Vehicles / Buried pipe Location & Mapping
